MANDATORY BULLETIN

Number: UFM-13 – 1/2009 Date of issue 24.3.2009 Applicable for UFM-13 from s.n. 1 to s.n 123 and UFM-11 from s.n. 1 to 18

Mandatory bulletin UFM-13 - 1/2009

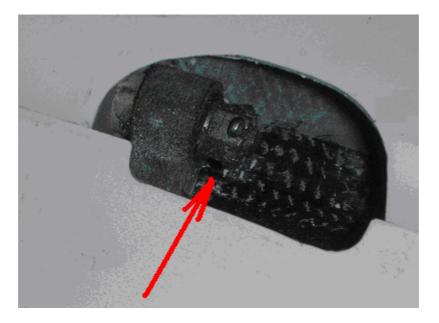
- B.4. Push out carefully the control surface hinges from the stabilizer hungs. Slightly push the control surface in axial direction to the hung axis and at the same time swing the control surface in its deflections. When the middle hinge gets out of the hung then remove the control surface backwards.
- B.5. Check the condition of elevator hungs. Take the hung by hand at the place of turning axis and posh slightly (cca 5-10 N) upwards backwards and check if the hung is hard and if there are no traces of damage or delamination. Check gradually all 5 hungs.

- B.2, Dismount the elevator according to the description in Flight manual aircraft assembly and disassembly.
- B.3. Place the elevator at a suitable place, remove the main middle hinge castle nut security pin, loosen and unscrew the nut and put it at a predefined place.

- B.6. Clean and grease elevator hungs on the stabilizer and hung plugs on the control surface. Set the elevator to the hungs, set the washer, screw and tighten castle nut on the hinge of middle hung and match the nut cut with the hole for hinge safety pin. When the nut is tightened, then check free movements of the control surface in its deflection set. Movement must be free, without floundering. Secure the castle nut with a new safety pin.
- B.7. Mount the elevator according to the description in flight manual.
- B.8. Check the proper assembly and control operation.
